California's Cowell Lime Works Barn

The Background

The Takedown

The Reconstruction

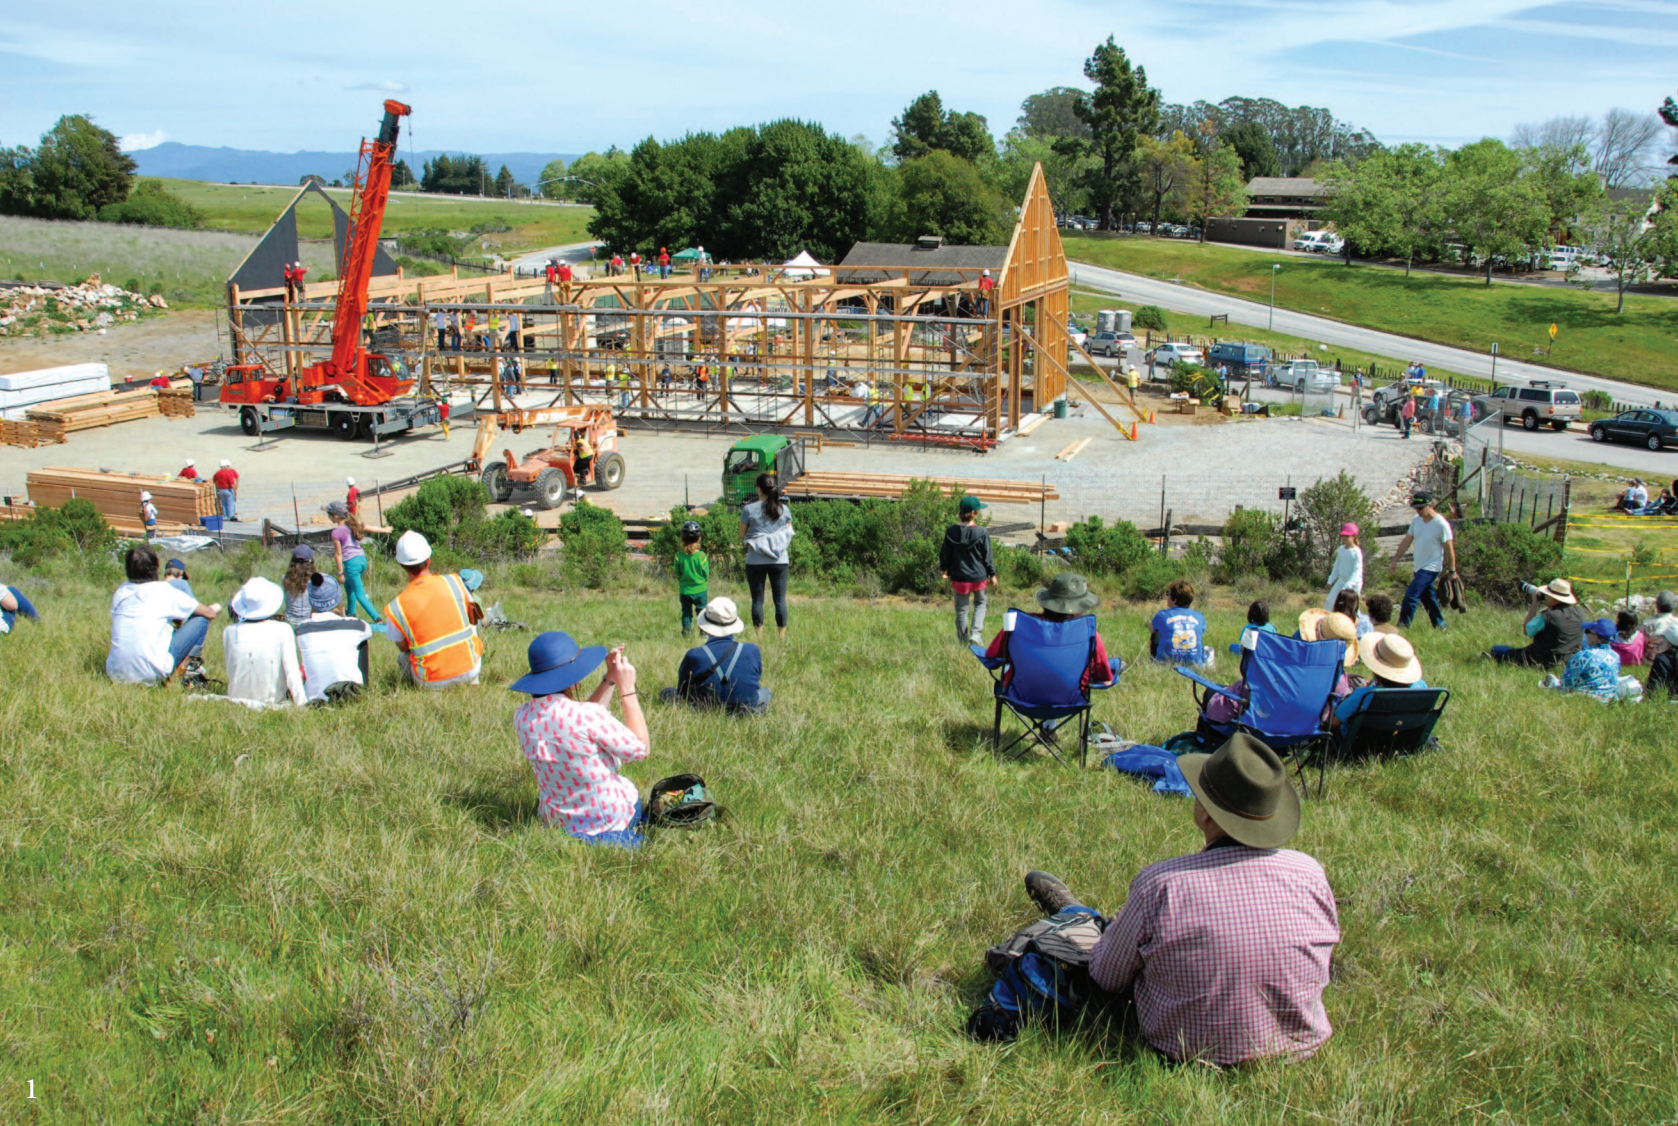
1 Mid-raising of reconstructed Cowell Lime Works barn, 2015. New frame measures 40 ft. 8 in. by 116 ft. 11 in.

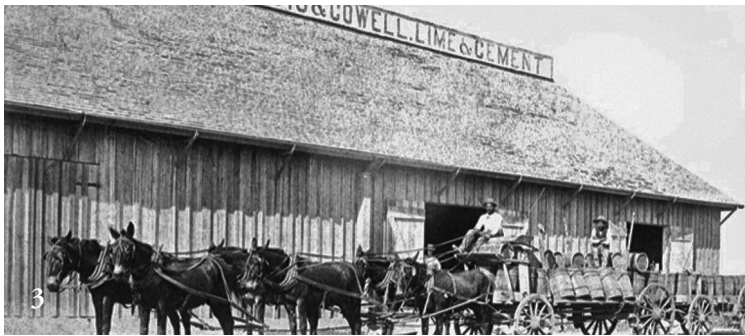
3 Cowell Lime Works warehouse near Cowell Wharf. Lime was shipped out to ports along California coast.

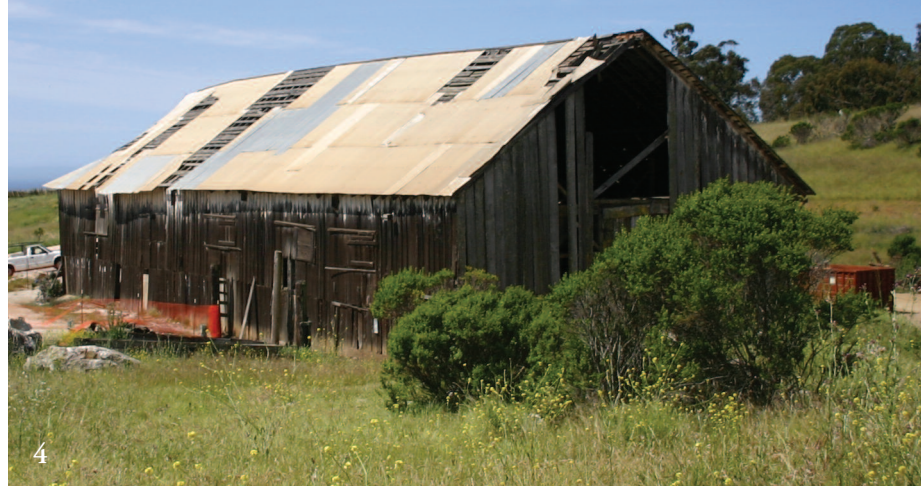
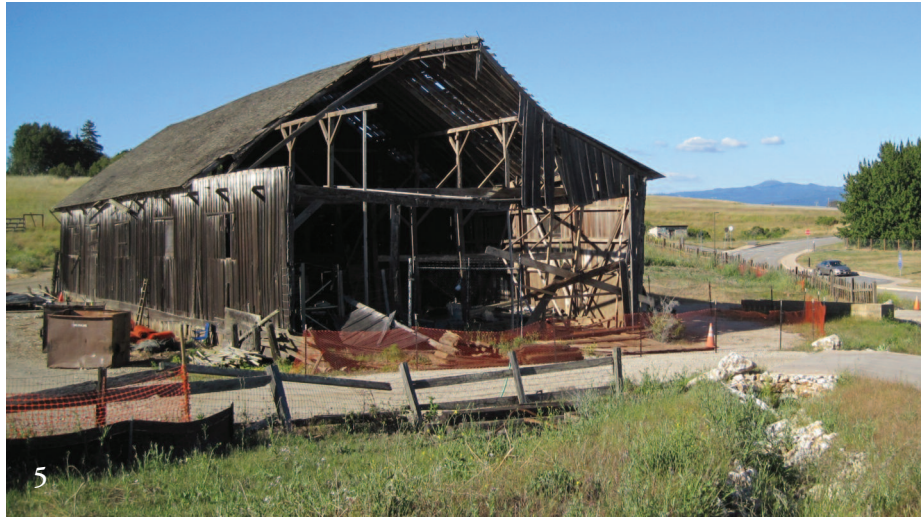
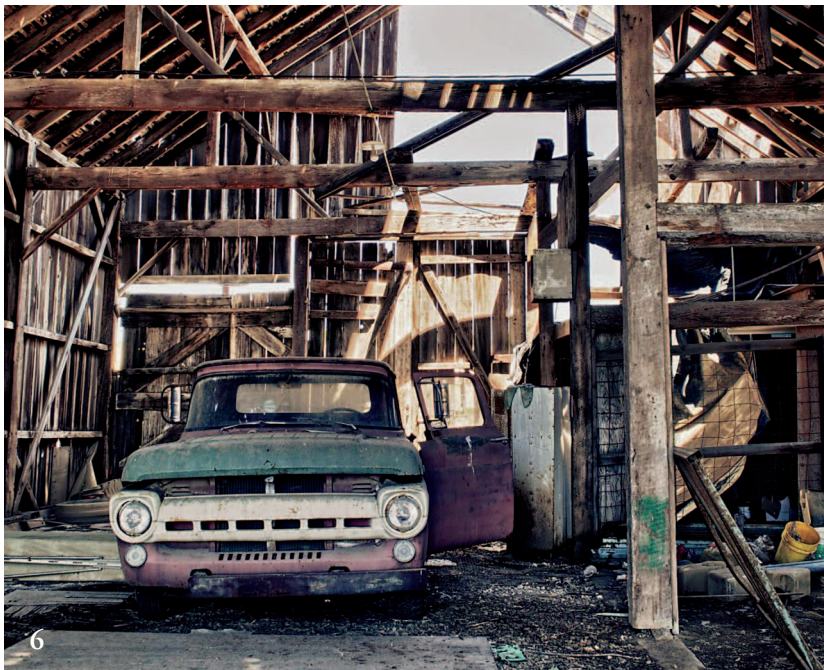
4-6 Barn seen in 2006 (upper photo) and 2010; interior in 2011.

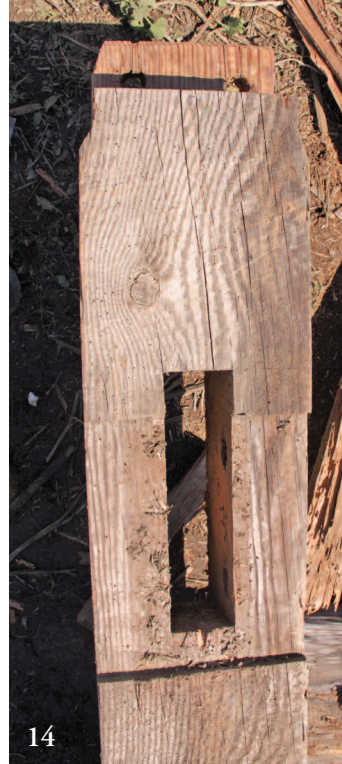
13, 14 Half-dovetail tenons at tie beam ends were wedged down onto their sloped seats in wall posts, and pinned for good measure. Wedge, not shown, fitted mortise above housing.

The wedged half-dovetail tying joint, though found in historic barns in Eastern states, I had not encountered in any other California or Nevada barn. Considering the 40-ft. span of the tie beam, the builder made the right choice, as the wedged half-dovetail puts the forces on the sloped interfaces of the joint rather than on the fixing pins across the joint.

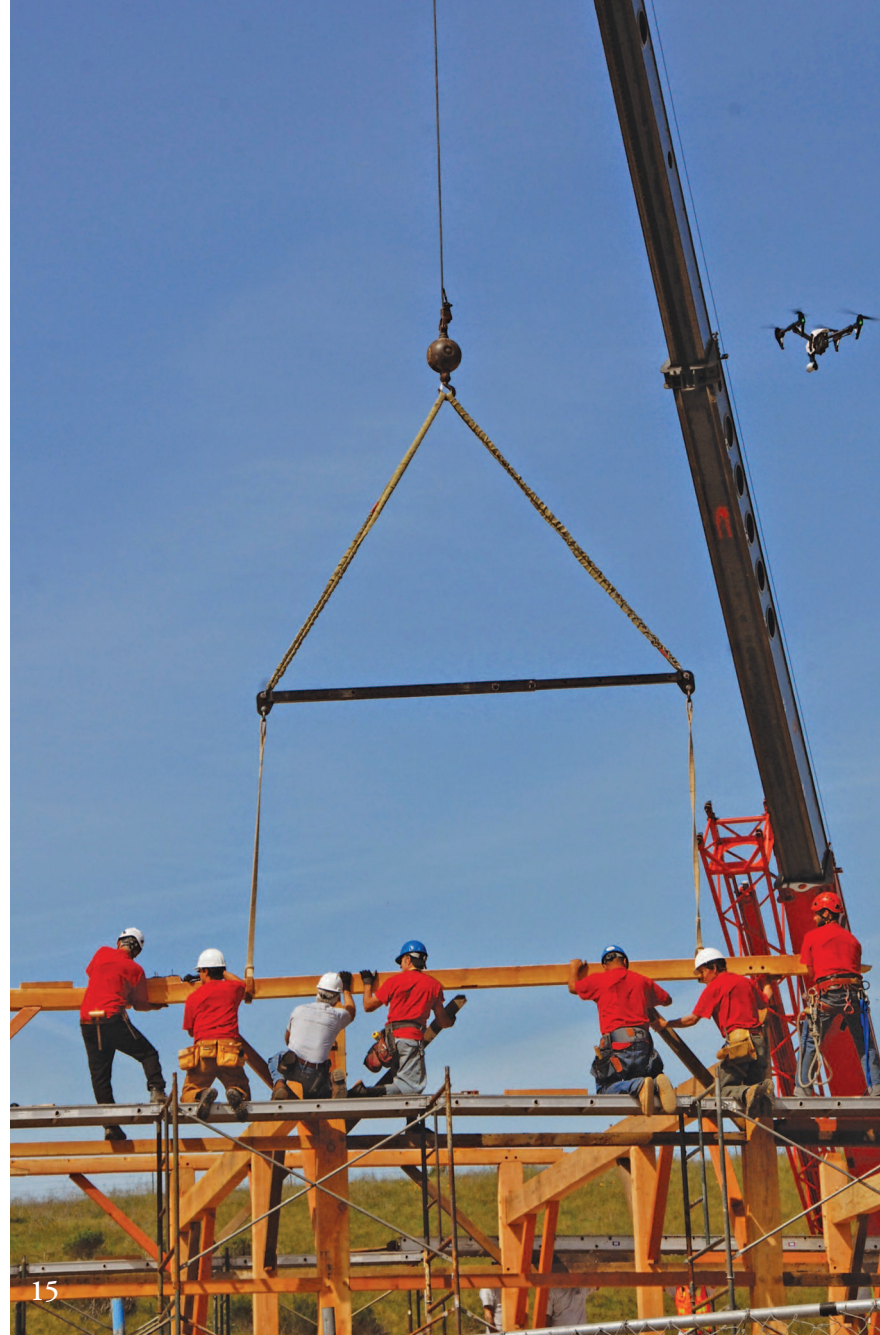
15 At mid-raising, red-shirted crew sets plate segment over waiting scarf-end and multiple braces. Drone observes.

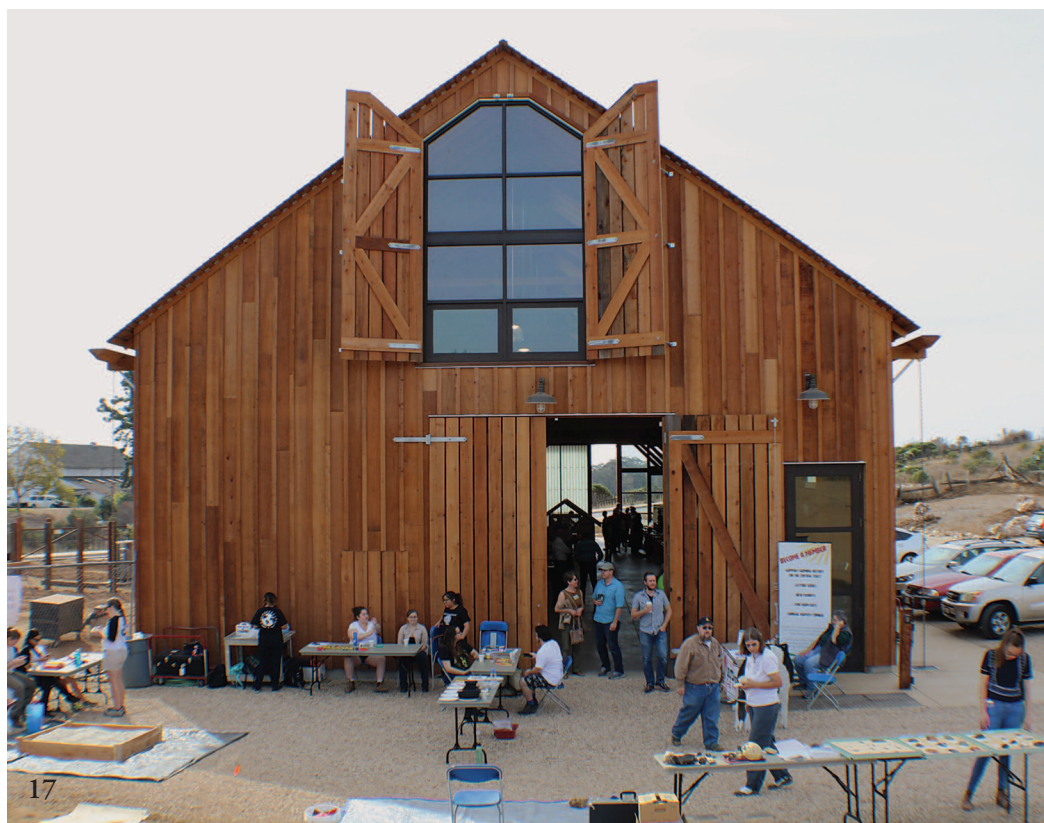
17 Barn in service hosting history fair, October 2015. Note wood gutters with rain chains leading to flush drains at grade.
